Conservative Treatment of the Worn Dentition with Adhesive Composite Resin

Howard E. Strassler, D.M.D., F.A.D.M., F.A.G.D.

Professor and Director of Operative Dentistry
Department of Endodontics, Prosthodontics, and Operative Dentistry
University of Maryland Dental School

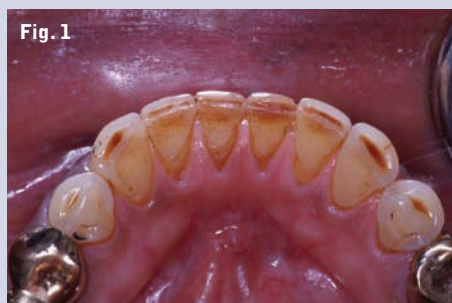
Fig. 1 Wear of the mandibular incisors into the dentin. **Fig. 2** Wear of the maxillary incisors into the dentin. **Fig. 3** Wear, due to bruxism, can contribute to shortening of the incisal edges of the maxillary incisors and chipping of the edges. **Fig. 4** Preoperative view of worn mandibular anterior teeth and premolars. **Fig. 5** Unsupported, chipped enamel finished using an abrasive disk.

As patients get older and keep their teeth longer, the wear of the incisal edges of anterior teeth has become more pervasive. Some have viewed tooth attrition as reaching epidemic proportions. In most cases, attrition of the mandibular incisors is viewed as loss of the enamel incisal edge, leaving the dentin exposed (Fig. 1). This is readily visible by the patient, especially when the dentin picks up stain. In the case of the maxillary incisors, the wear may not be readily apparent to the patient because it is on the lingual surfaces of the teeth (Fig. 2). But the wear may be evident due to chipping of the incisal edges (Fig. 3) and an increase in incisal translucency where the underlying enamel has worn thin.

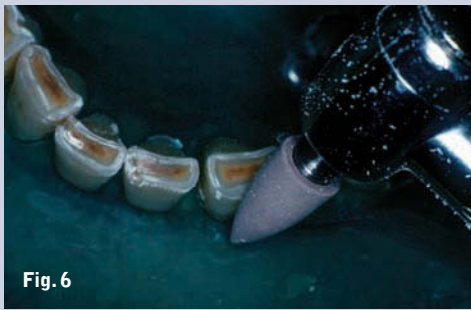
Fig. 6 The enamel polished with a rubber abrasive point. **Fig. 7** Mandibular teeth after removing unsupported enamel and polishing. **Fig. 8** The teeth were prepared to a pulpal depth of 1.0 mm as evidenced by the cutting length of the #330 bur.

Before the tooth preparations, the enamel surfaces were finished and polished to remove unsupported enamel using an abrasive disk system (Soflex, 3M-ESPE, Minneapolis, MN) (Fig. 5) from medium grit to fine, and a final polish of the enamel was done with an intraoral, rubber-abrasive, enamel-ceramic polishing point (Dialite, Brasseler USA, Savannah, GA) (Fig. 6). The finishing and polishing of the enamel surface removes any irregularities of the enamel and loose enamel rods that can fracture after the completion of the restoration. (Fig. 7)

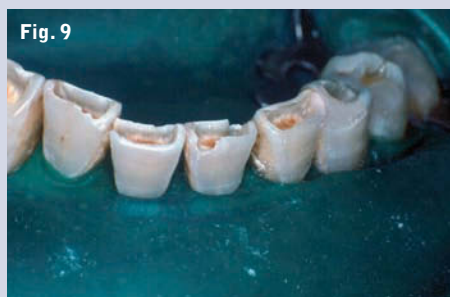
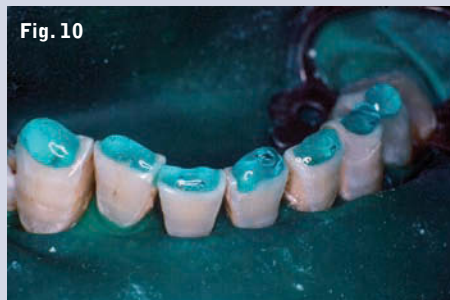
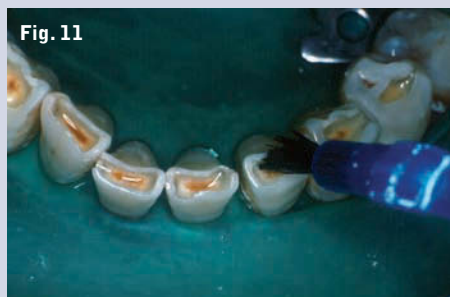
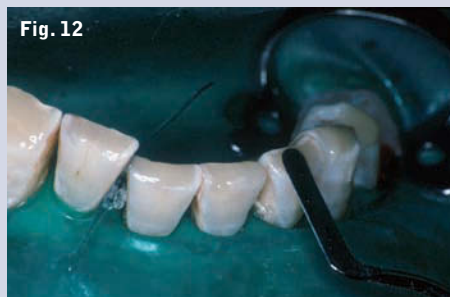
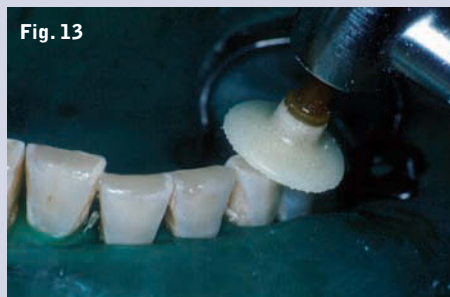
Fig. 9 Completed preparations. **Fig. 10** The preparations were etched with a 32% phosphoric acid gel for 15 seconds. **Fig. 11** A fifth-generation adhesive was applied to the etched tooth preparations. **Fig. 12** Care was taken to shape the composite resin with a plastic-filling instrument to minimize excess. **Fig. 13:** Initial finishing was done with an Enhance polishing disk.

Using a small, pear-shaped 330 bur, a preparation was made into the dentin to a depth of 1.0 mm. (Fig. 8) For smaller-sized lesions, a 329 bur can be used because it has a length of 1.0 mm, which is the preparation depth desired. A periodontal probe can also be used to verify the pulpal depth of 1.0 mm of the tooth preparation of all enamel walls. Past clinical experiences and evaluations over the last 10 years has shown this depth into the dentin allows adequate composite resin thickness to provide longevity to the restoration in function. The preparation removes only dentin, leaving a shell of enamel. For this patient, the enamel was thin in some areas and there was enamel chipping on the facial surfaces of some teeth. (Fig. 9) This is not a problem because the composite resin will restore that surface.

After tooth preparation, the teeth were etched for 15 seconds with a 32% phosphoric acid etchant (Uni-Etch, Bisco, Schaumburg, IL) (Fig. 10) and then rinsed with an air-water spray for 10 seconds. The tooth was lightly dried, leaving a moist dentin surface. A single component, fifth-generation adhesive (One-Step, Bisco, Schaumburg, IL) was applied to the tooth preparation with a disposable brush (BendaBrush, Centrix, Shelton, CT). (Fig. 11) The adhesive was gently air-dried, keeping the air syringe 4-6 inches from the surface of the tooth so the adhesive was not thinned before light curing. The adhesive was light-cured for 20 seconds. A wear-resistant, hybrid composite resin (TPH, Dentsply/Caulk, Milford, DE) was placed into the incisal preparations. The composite resin was shaped to the tooth surfaces using a plastic filling instrument (AB1 PFI, Hu-Friedy, Chicago, IL) so there was little excess needing to be finished (Fig. 12). The composite resin was then light-cured for 20 seconds for each tooth.

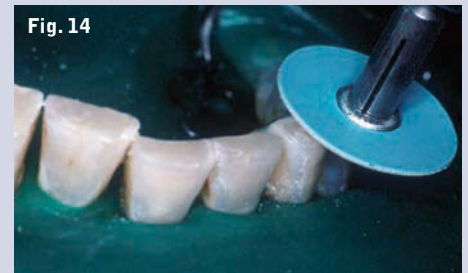
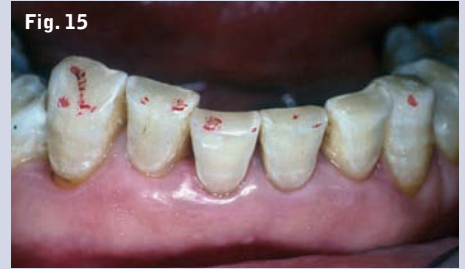
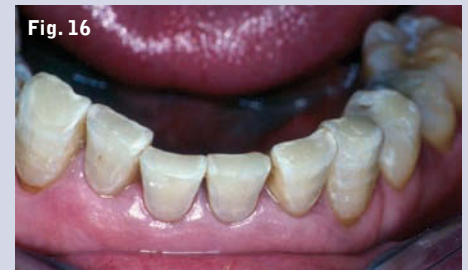
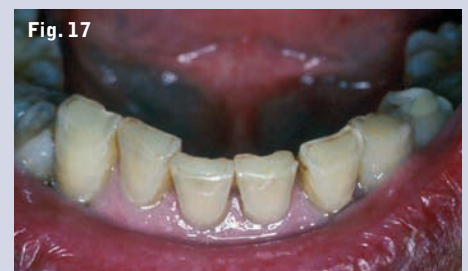
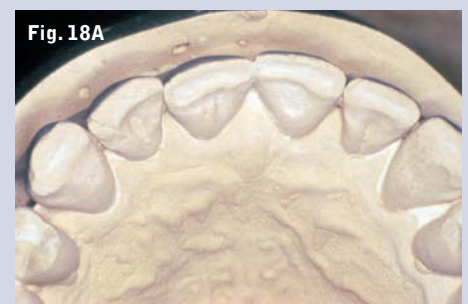
Fig. 14 Final polish was accomplished with a superfine Soflex polishing disk. **Fig. 15** Occlusion is adjusted and verified with ultrathin articulating film. **Fig. 16** The completed restorations are functional and esthetic. **Fig. 17** At seven years, the restorations are functioning well. **Fig. 18A** A study cast can demonstrate the degree of wear present.

The composite resin placement, as described, leaves very little excess. In most cases, an abrasive-backed disk is not necessary. The finishing can be accomplished using an aluminum oxide impregnated silicone disk (Enhance, Dentsply/Caulk, Milford, DE) (Fig. 13). The final polish was done using a superfine Soflex disk (3M, St. Paul, MN). (Fig. 14) The rubber dam was removed, and all occlusal movements were checked using a very thin, two-sided occlusal film (AccuFilm II, Parkell, Farmingdale, NY). (Fig. 15) It should be noted: the composite resin restores function to areas the wear had removed function. In this case, note the facial surfaces of the mandibular right and left canines. They have been restored to function in lateral excursions to protect the dentition with canine disclusion. A hard, acrylic, maxillary occlusal nightguard was fabricated to protect the dentition from parafunctional wear. The restored incisal edges have not only made the teeth more wear resistant, but also have created a more esthetic result. (Fig. 16) After seven years, the restorations are functioning well and have minimized tooth destruction due to wear. (Fig. 17)

ation due to excessive incisal translucency. With the use of a cast, (Fig. 18A) the patient was shown the degree of wear that had occurred to lingual surfaces of his maxillary anterior teeth. The clinical appearance of these teeth demonstrated moderate wear of the maxillary incisors and canines (Fig. 18B).

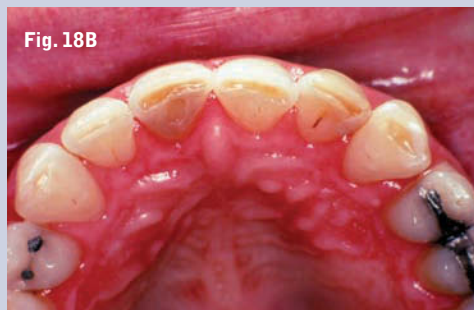
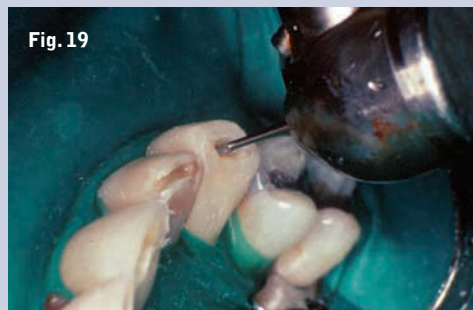
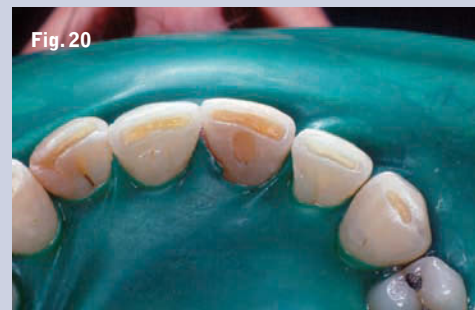
Fig. 18 B The study cast appearance correlates to the clinical degree of incisal and lingual wear present. **Fig. 19** When preparing the areas of worn dentin, orient the bur to be at right angles to the surfaces being prepared. **Fig. 20** Preparations completed.

The teeth were prepared using a #330 pear-shaped bur to a depth of 1.0 mm. To maintain a constant preparation depth, the bur was held at right angles to the surfaces being prepared. (Fig. 19) When preparing the lingual surfaces of the maxillary incisors and canines, angle the bur so the cavosurface margins are at right angles to the tooth surface. This will provide for a bulk of composite resin that will wear and fracture. It is important, in the shallowest areas of tooth preparation, a depth of 1.0 mm be attained. (Fig. 20)

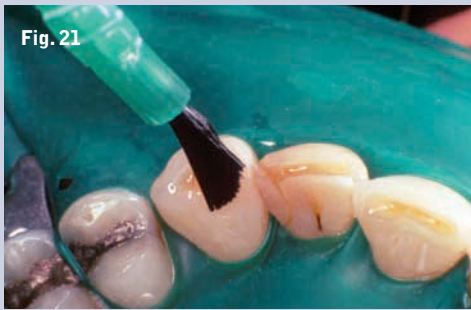
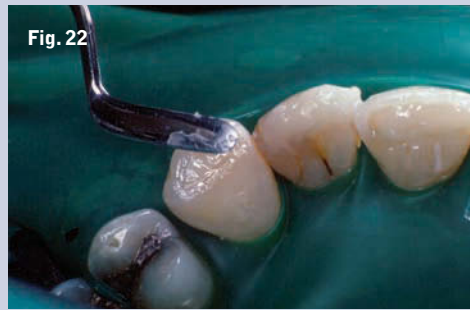
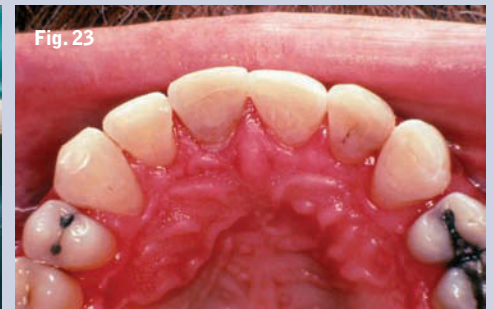
Fig. 21 A fifth-generation adhesive was applied and light cured for 20 seconds. **Fig. 22** Adapting the composite resin to the cavity preparations. **Fig. 23** Restoration of the lingual surfaces of the maxillary incisors and canines.

The teeth were etched for 15 seconds with a phosphoric acid etchant. A single component, fifth-generation adhesive (Single Bond, 3M-ESPE, Minneapolis, MN) was applied using a disposable BendaBrush (Fig. 21) and light-cured for 10 seconds. A wear-resistant, nanohybrid composite resin (Filtek Supreme Plus, 3M-ESPE, Minneapolis, MN) was placed into the cavity preparations, adapted with a hand instrument (Fig. 22), and light cured for 20 seconds. Finishing, verification of occlusion, and polishing were accomplished as previously described. The result eliminated incisal translucency

and restored the lingual surfaces of the maxillary anterior teeth. (Fig. 23)
